USAAVRADCOM-TR-82-D-36

VERIFICATION TESTING OF AN AH-1S WIRE STRIKE  
PROTECTION SYSTEM (WSPS)

December 1982

APPLIED TECHNOLOGY LABORATORY  
U. S. ARMY RESEARCH AND TECHNOLOGY LABORATORIES (AVRADCOM)  
Fort Eustis, Va. 23604

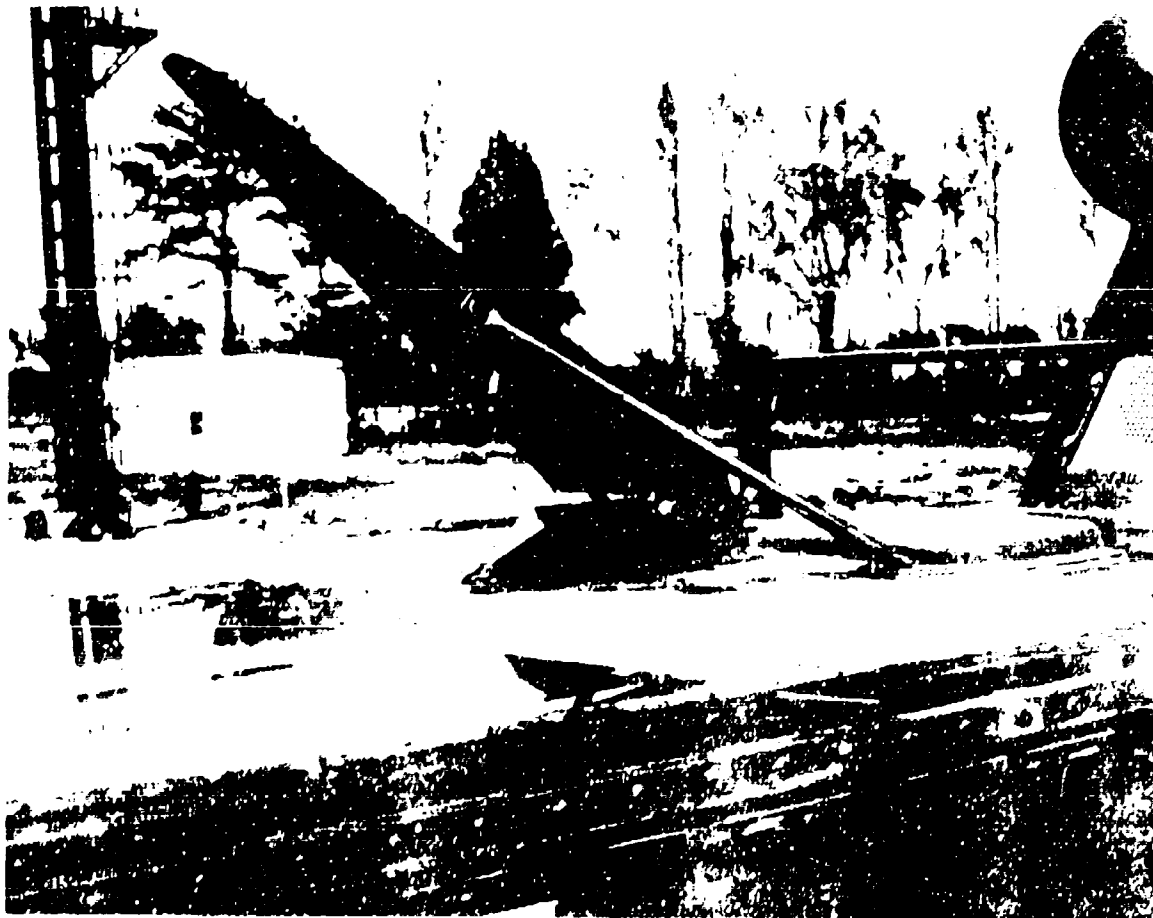
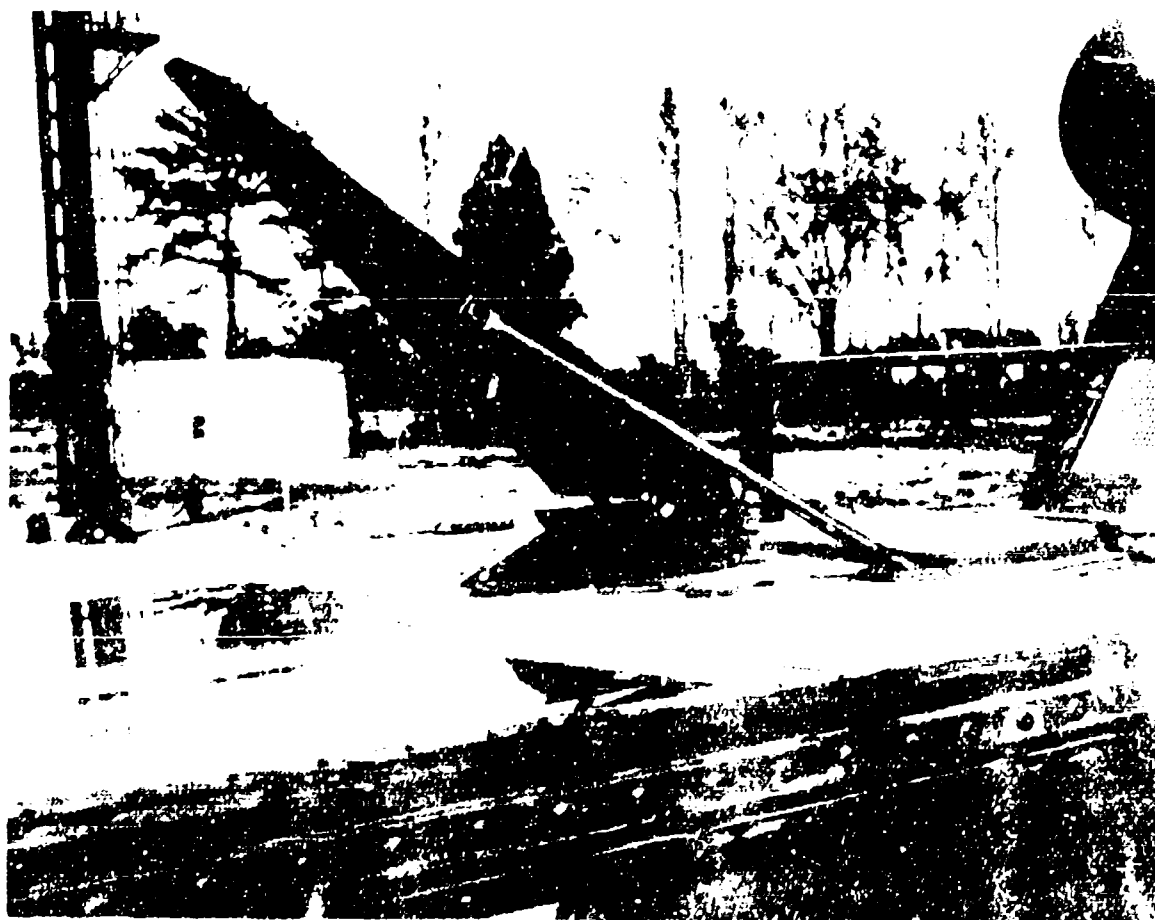
Figure 6. Upper cutter.

The AH-1S WSPS tested has five major components: the upper cutter, which protects the main rotor controls (Figure 6); the TSU deflector, which prevents a wire from snagging on the TSU optics or supporting structure (Figure 7); the chin cutter, which helps prevent a wire from snagging on the 20mm cannon turret (Figure 8); a lower cutter to protect the skid gear (Figure 9); and a deflector with a sawtooth edge insert mounted on the right forward wind shield structure to provide some protection from an air data boom wire snag (Figure 10).

The WSPS is a passive system, having no moving parts. Upon wire impact, the helicopter momentum deflects the wire or cable into the upper, chin, or lower wedge shaped cutter, which notches it to the extent required for tensile failure.

3. The forward edges of the upper cutter mounting plate are minor snags that can be easily eliminated.
4. The lower cutter components did not provide smooth wire deflection into the cutting edges. This minor problem could be easily corrected in a production design.

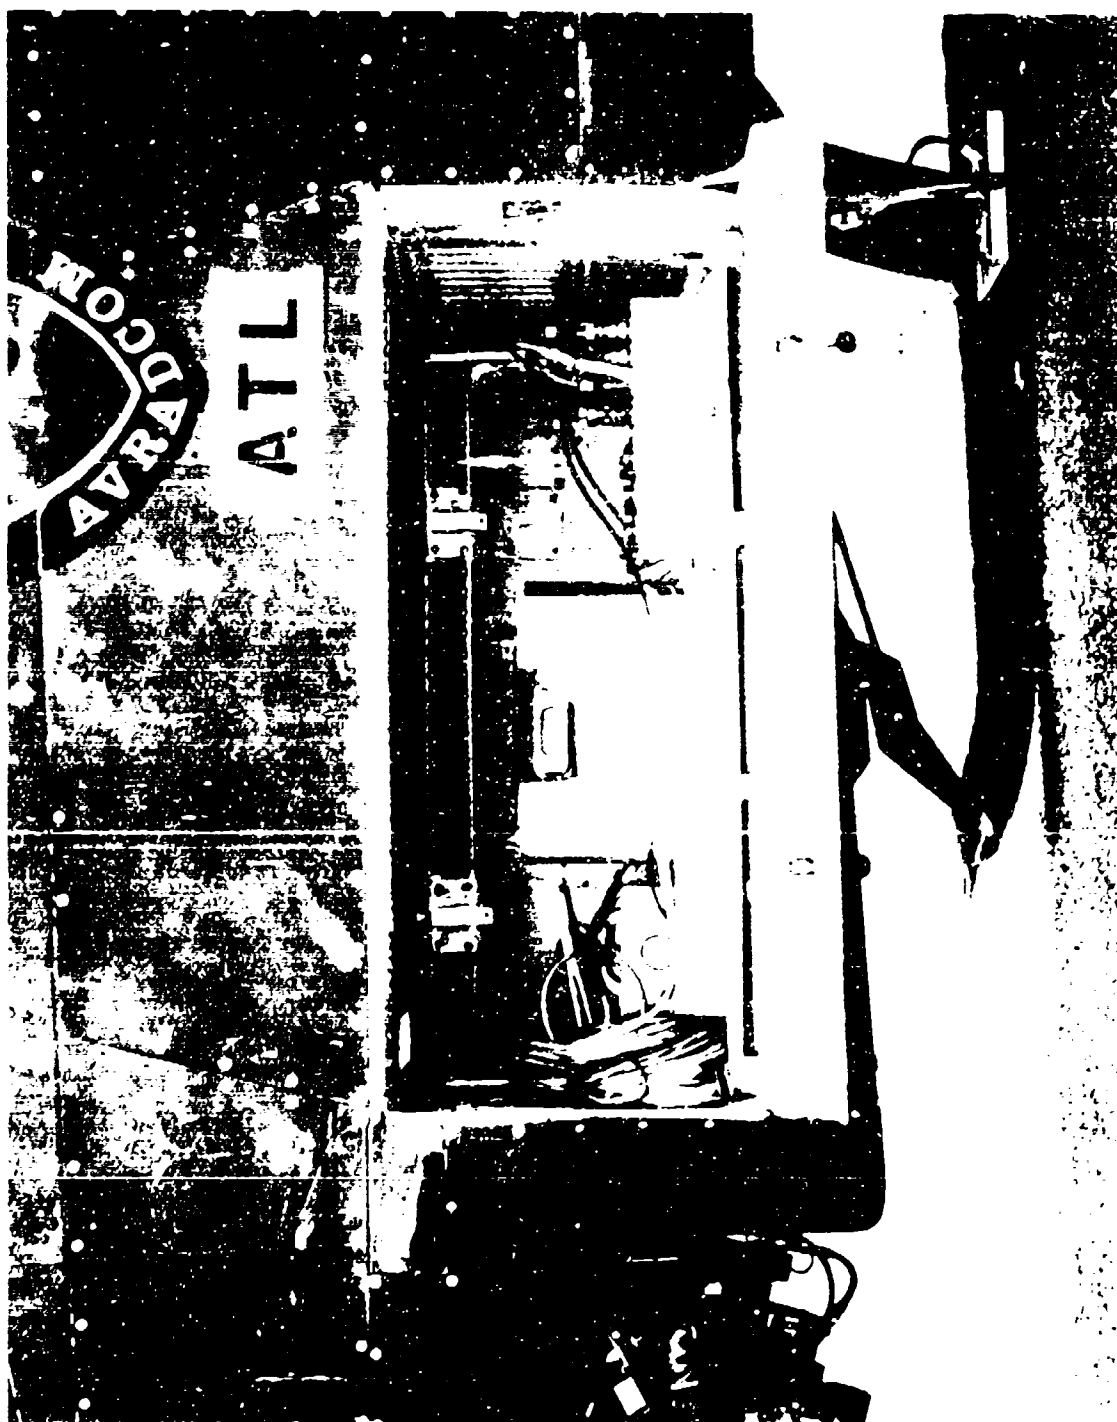
Figure 11. On-board camera circuitry.

Mounts for four high-speed (400 frames/sec) 16mm motion picture cameras were installed on the test helicopter. One mount was placed in the cockpit to provide a pilot's eye view during the tests. The other mounts were placed to permit views of the upper cutter, chin cutter, and lower cutter and were located on the rotor hub, right side of the 20mm cannon turret, and right skid landing gear, respectively (Figure 3). A 10mm wide angle lens was used with all on-board cameras because of its wide field of view and its ability to obtain visual data at close range. These cameras were powered by an on-board NiCad battery and were activated by a lanyard switch through circuitry located in the AH-1S ammunition bay (Figure 11). At the T-minus-3-seconds point of the aircraft release countdown, the lanyard pin is manually pulled, thus permitting camera run-up prior to release.

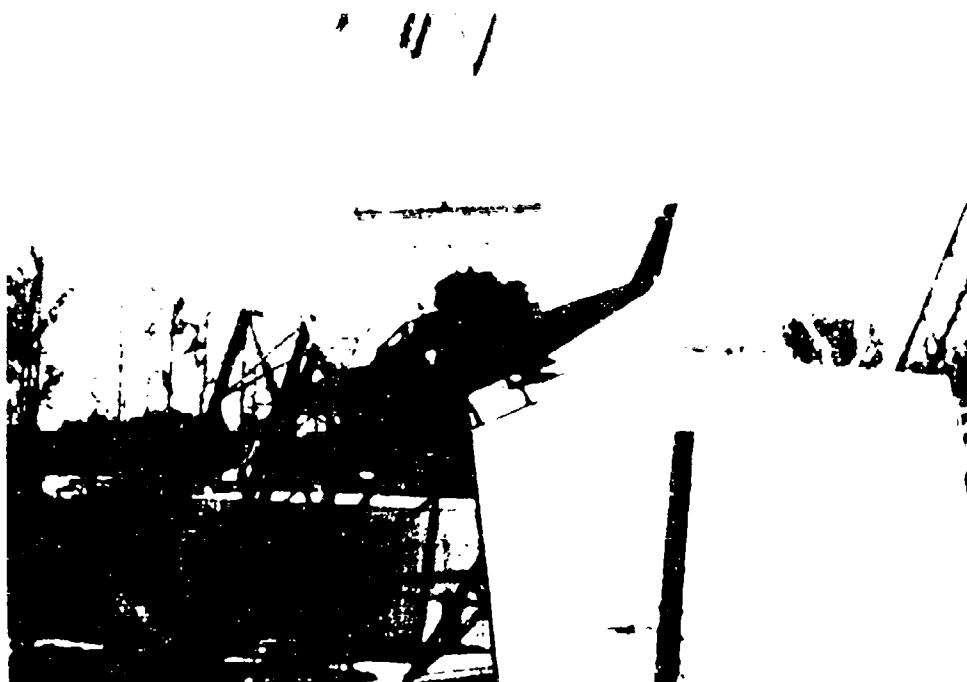
Figure 20. 15-knot test pullback position.

Difficulty was encountered in accomplishing planned test C (15 knot impact) described in Table 1. To obtain the nose-up attitude, ballast was shifted aft, resulting in a tail-heavy aircraft. The pullback platform had been set for the 40 knot test so that the pullback cable was in line with the aircraft cg at the release point. In a test swing without a strung wire, the tail dropped upon release and created a severe unpredictable pitch oscillation that continued throughout the swing. This was largely due to the pullback cable not being in line with the aircraft cg. Attempts to dampen this motion using various aircraft rigging concepts were unsuccessful. The pullback platform was then moved as far back as possible and the pullback cable was run down through a pulley, located on the gantry at a height of 164 feet, to the aircraft, putting the pullback cable almost in line with the aircraft cg at the 15 knot pullback height. Lines were rigged from the swing cable spreader bar to each skid at fore and aft locations to help damp out the preloading effect. Swing tests without a wire were again conducted with much less pitch oscillation than earlier encountered. Film analysis showed the pitch variation to then be somewhat repeatable and the nose-up pitch attitude to be 8 degrees at the point where the wire would be contacted. Swing cable elongation for this test was estimated to be approximately 1 mm. The pullback position for the 15 knot test is shown in Figure 20.
